# **Yancey Fuel Solutions Tank Audit**

Model 3512

**Equipment Family ENGINE - GENERATOR SET**

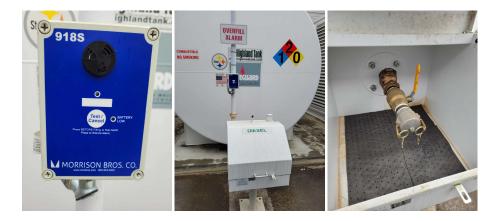
6,000 Gallons steel Material

## Comments: Remote fill port, overfill alarm
